Manhole Inspection Summary

Manhole # S29Q1_012MH

Insp Date: **4/12/09 12:01 PM**

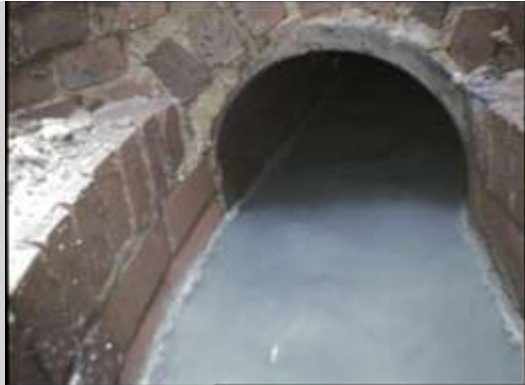
12 O'Clock Outflow

15 in. Circular Gravity Sewer
Pipe Out @ 12 O'Clock

Pipe Height: **16.8** (in.) Rod and Bar (Angled)
Pipe Material: **Clay** ☐ Pipe Lined
Invert Depth: **9.60** (ft.) Flow Characteristics: **Slow**
Deposits: ☒ None ☐ Mud ☐ Sludge ☐ Debris ☐ Grease
Silt Depth: (in.) Deposits Extent:
Infiltration: **None** Pipe Seal Cond: **Sound**

Drop: **None**

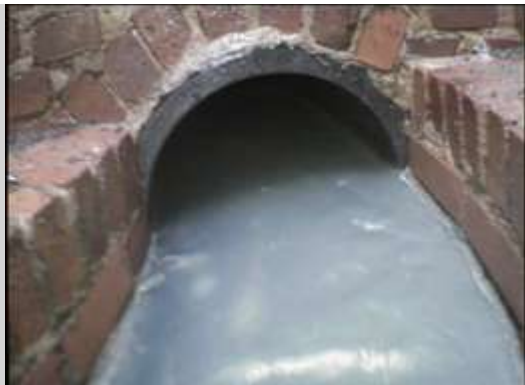
7 O'Clock Inflow

15 in. Circular Gravity Sewer
Pipe In @ 7 O'Clock

Pipe Height: **16.8** (in.) Rod and Bar (Angled)
Pipe Material: **Clay** ☐ Pipe Lined
Invert Depth: **9.40** (ft.) Flow Characteristics: **Slow**
Deposits: ☒ None ☐ Mud ☐ Sludge ☐ Debris ☐ Grease
Silt Depth: (in.) Deposits Extent:
Infiltration: **None** Pipe Seal Cond: **Sound**

Drop: **None**
